DOMINION STREET CLASS ENVIRONMENTAL ASSESSMENT **PUBLIC INFORMATION CENTRE #1**

> **INGLEWOOD COMMUNITY CENTRE NOVEMBER 30, 2016**

THE CORPORATION OF THE TOWN OF CALEDON

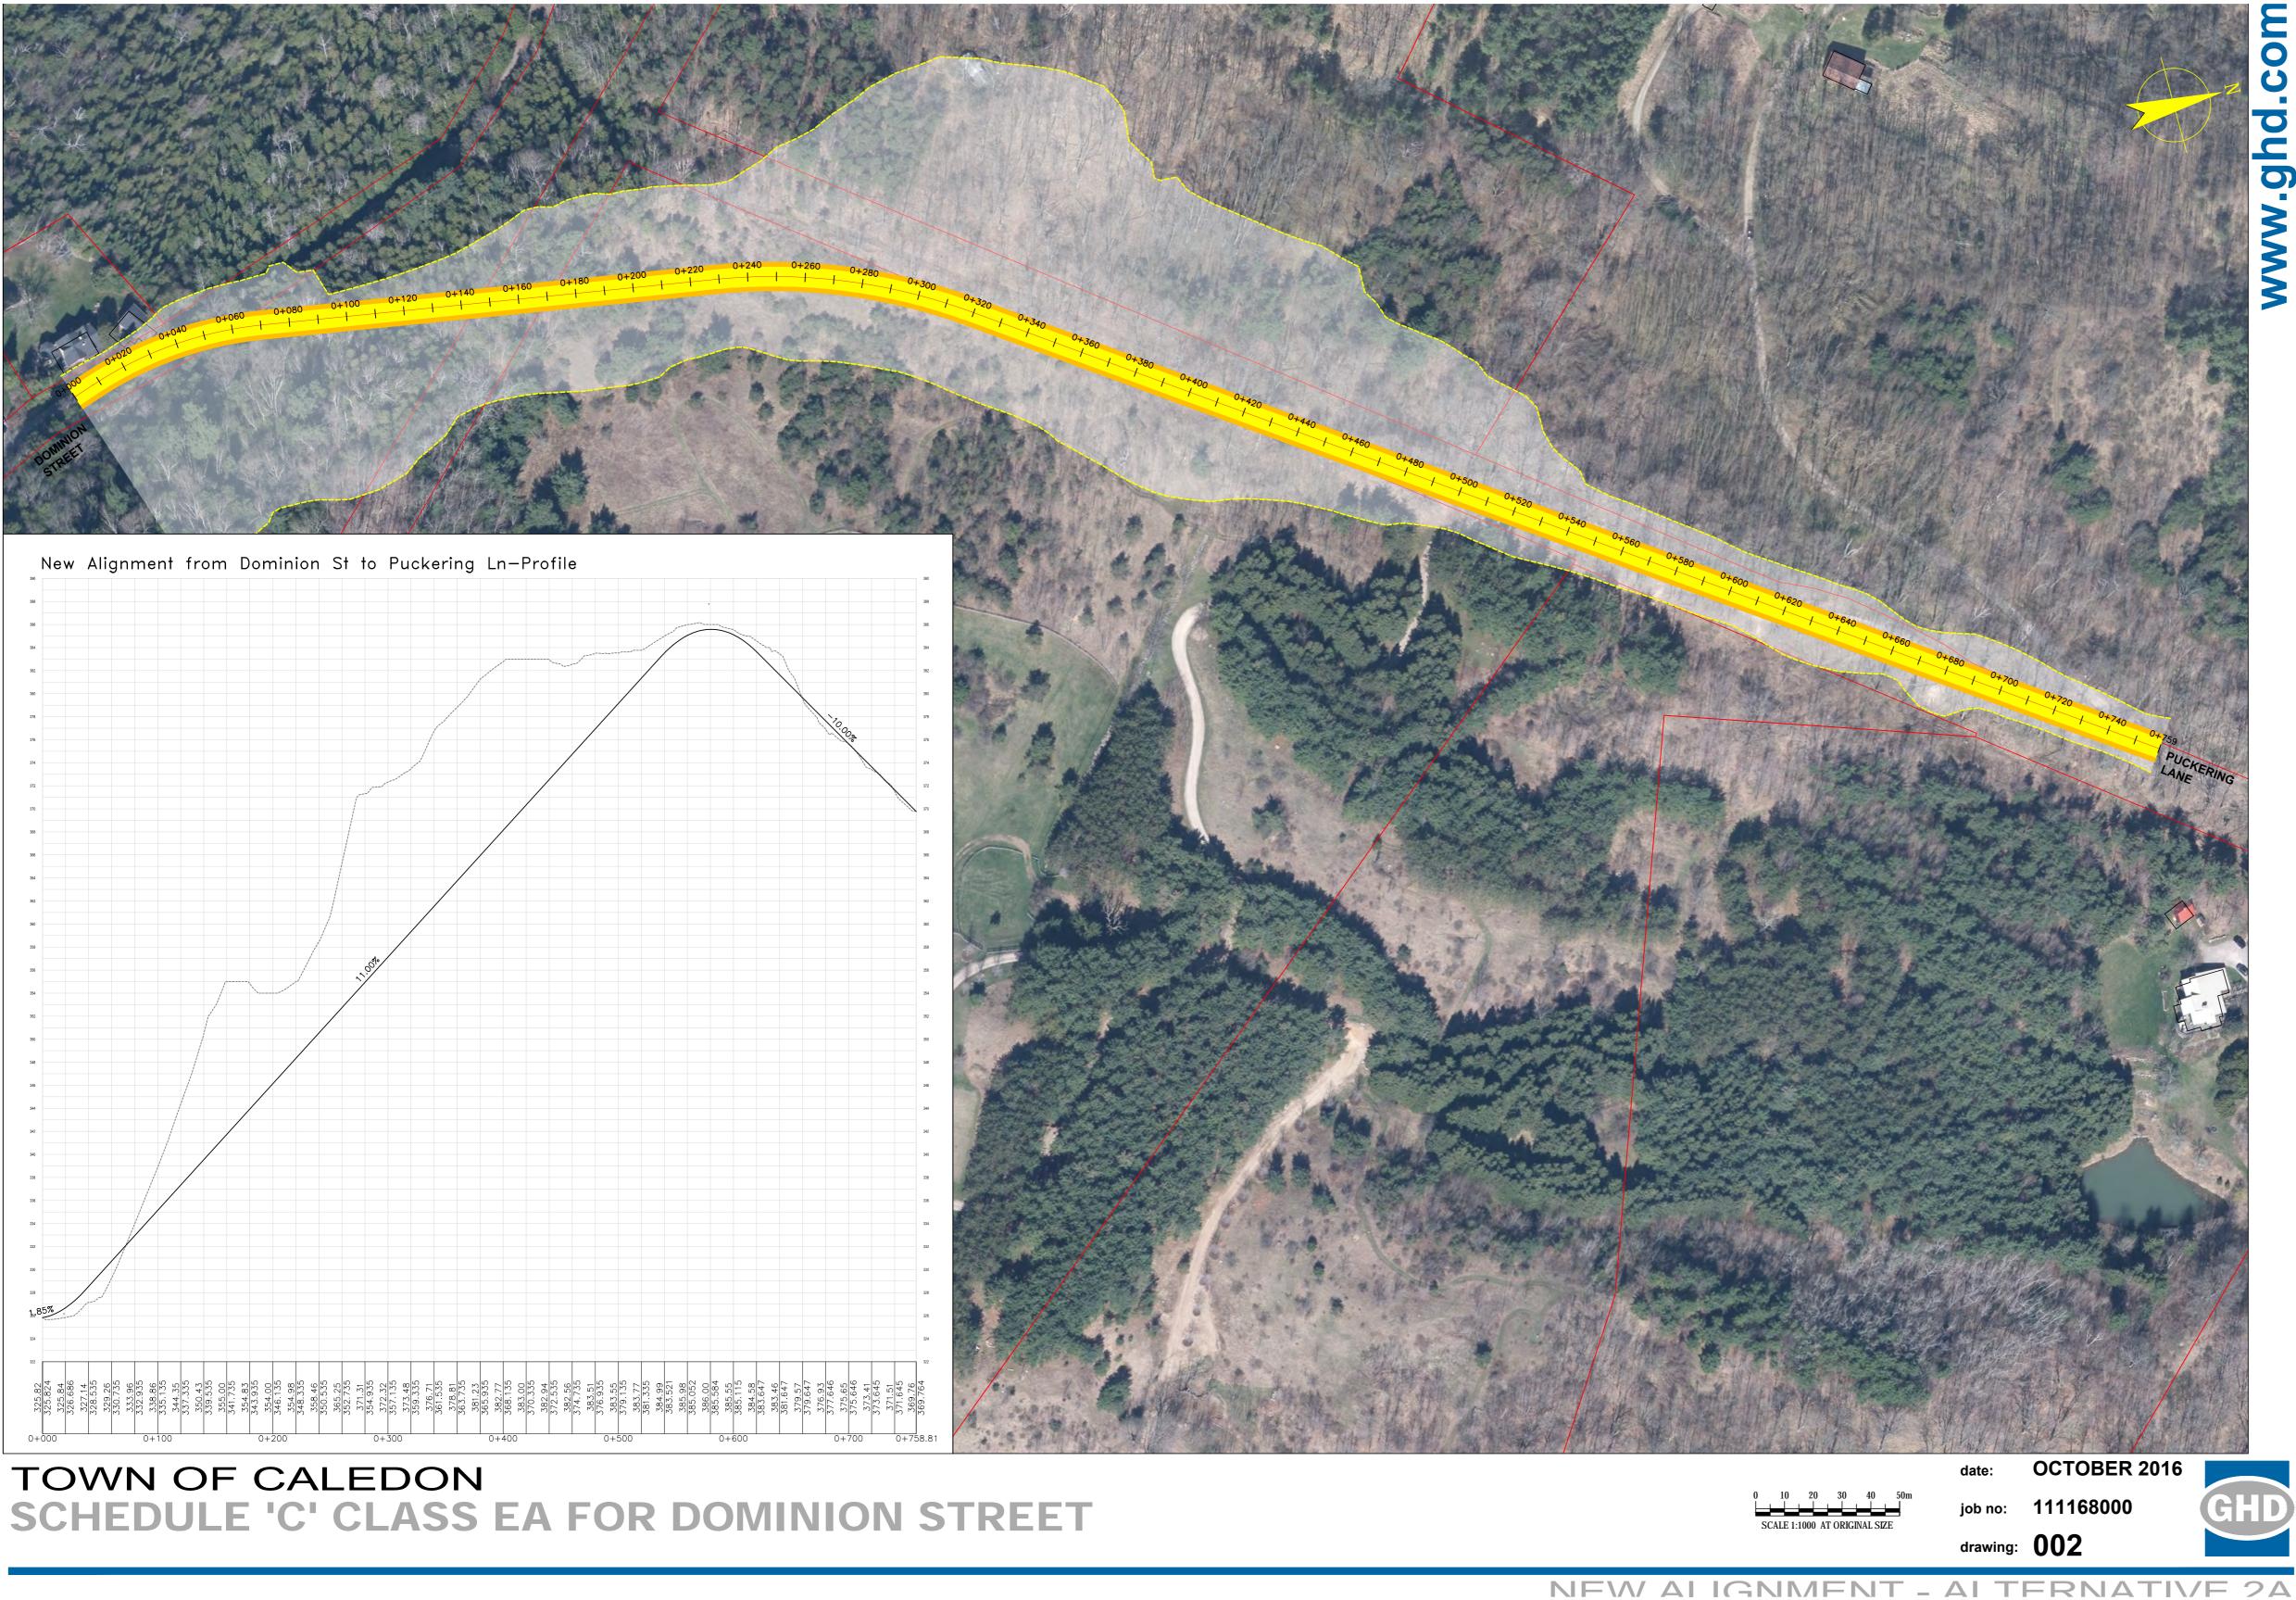
### **ALTERNATIVE 2A RE-ALIGNMENT** via PUCKERING LANE

Alternative 2A would require the connection of Dominion Street to Puckering Lane. The connection of west-end Puckering Lane and north-end Dominion Street would require an 11 percent grade given the significant change in elevation.

The estimated surface area potentially impacted from the preliminary configuration of Alternative 2A is approx. **48,000 m**<sup>2</sup>

An approximate 750 metres of additional road would be required to facilitate Alternative 2B.

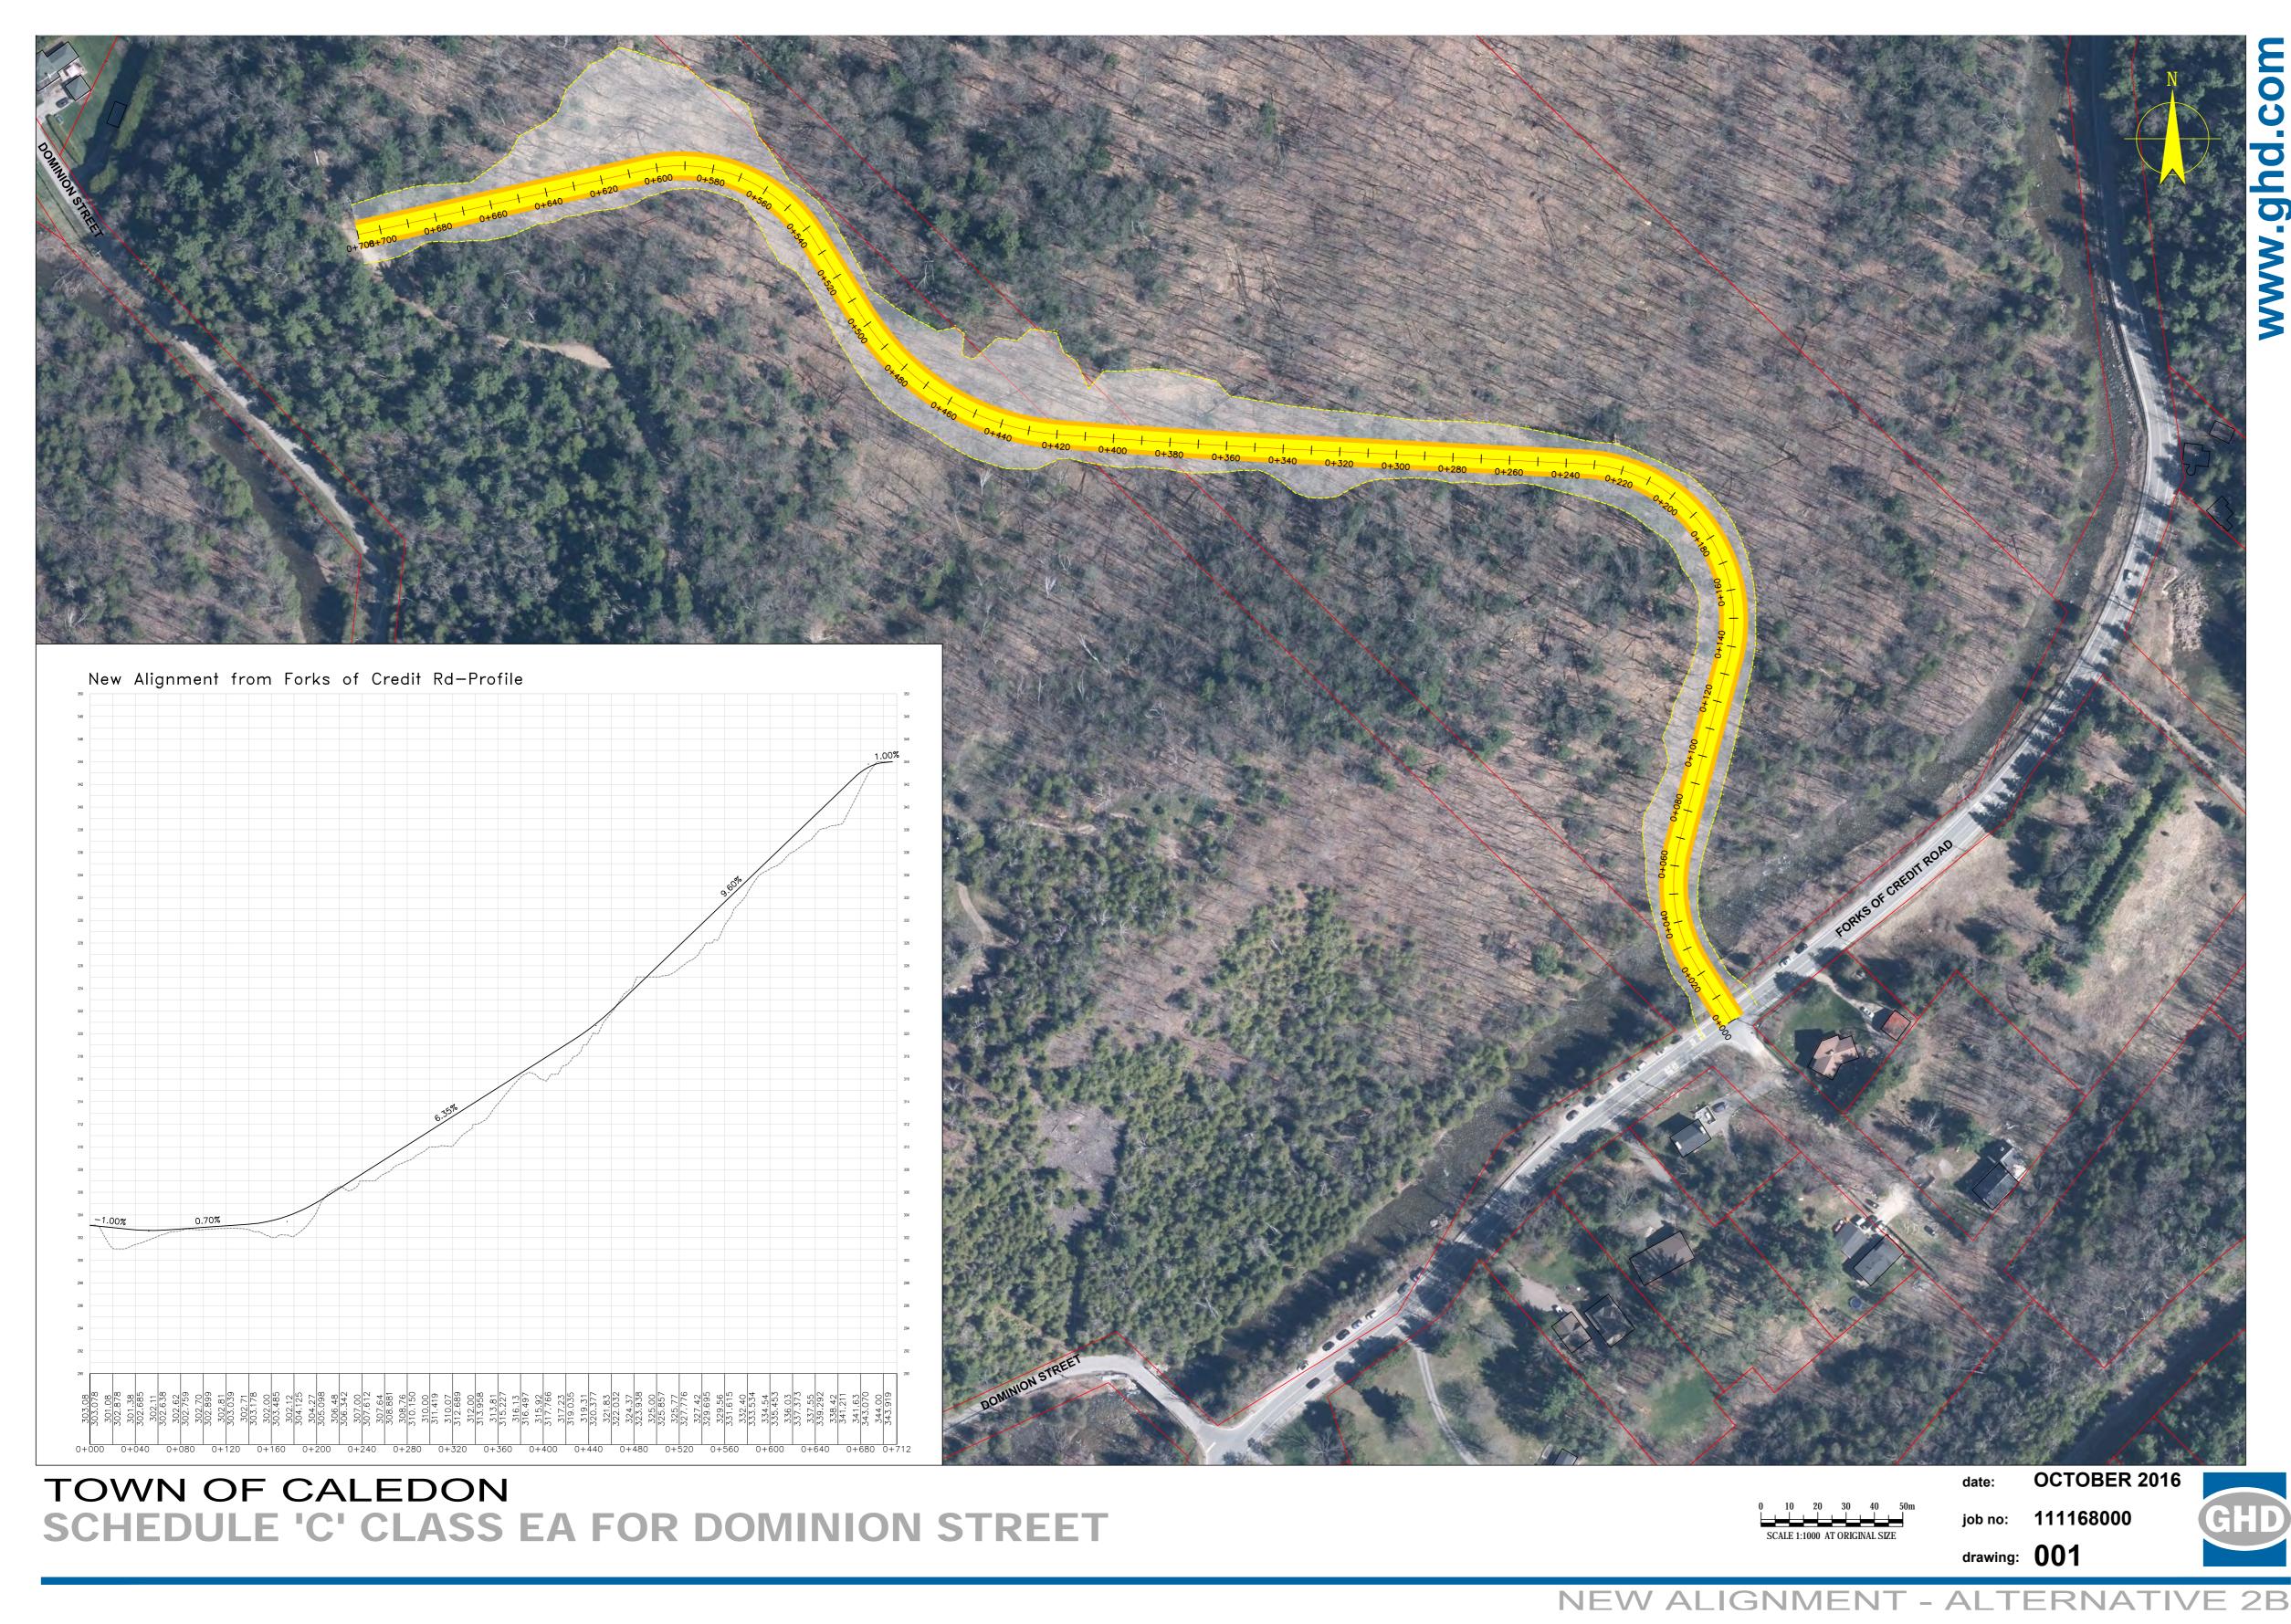
### **ALTERNATIVE 2B RE-ALIGNMENT** via FORKS OF THE **CREDIT ROAD**

Alternative 2B ivolves an alternative connection approximately 240 metres east of the current Forks of the Credit/Dominion Street intersection to connect to the existing laneway located approximately 240 m north of the existing intersection. This new connection would not affect any of the lands of the Forks of the Credit Provincial Park. A road grade falling within the 11 percent maximum appears to be feasible. A new bridge would be required to cross the Credit River.

The estimated surface area potentially impacted from the preliminary configuration of Alternative 2B is approx. **18,700 m**<sup>2</sup>

An approximate 700 metres of additional road would be required to facilitate Alternative 2B.

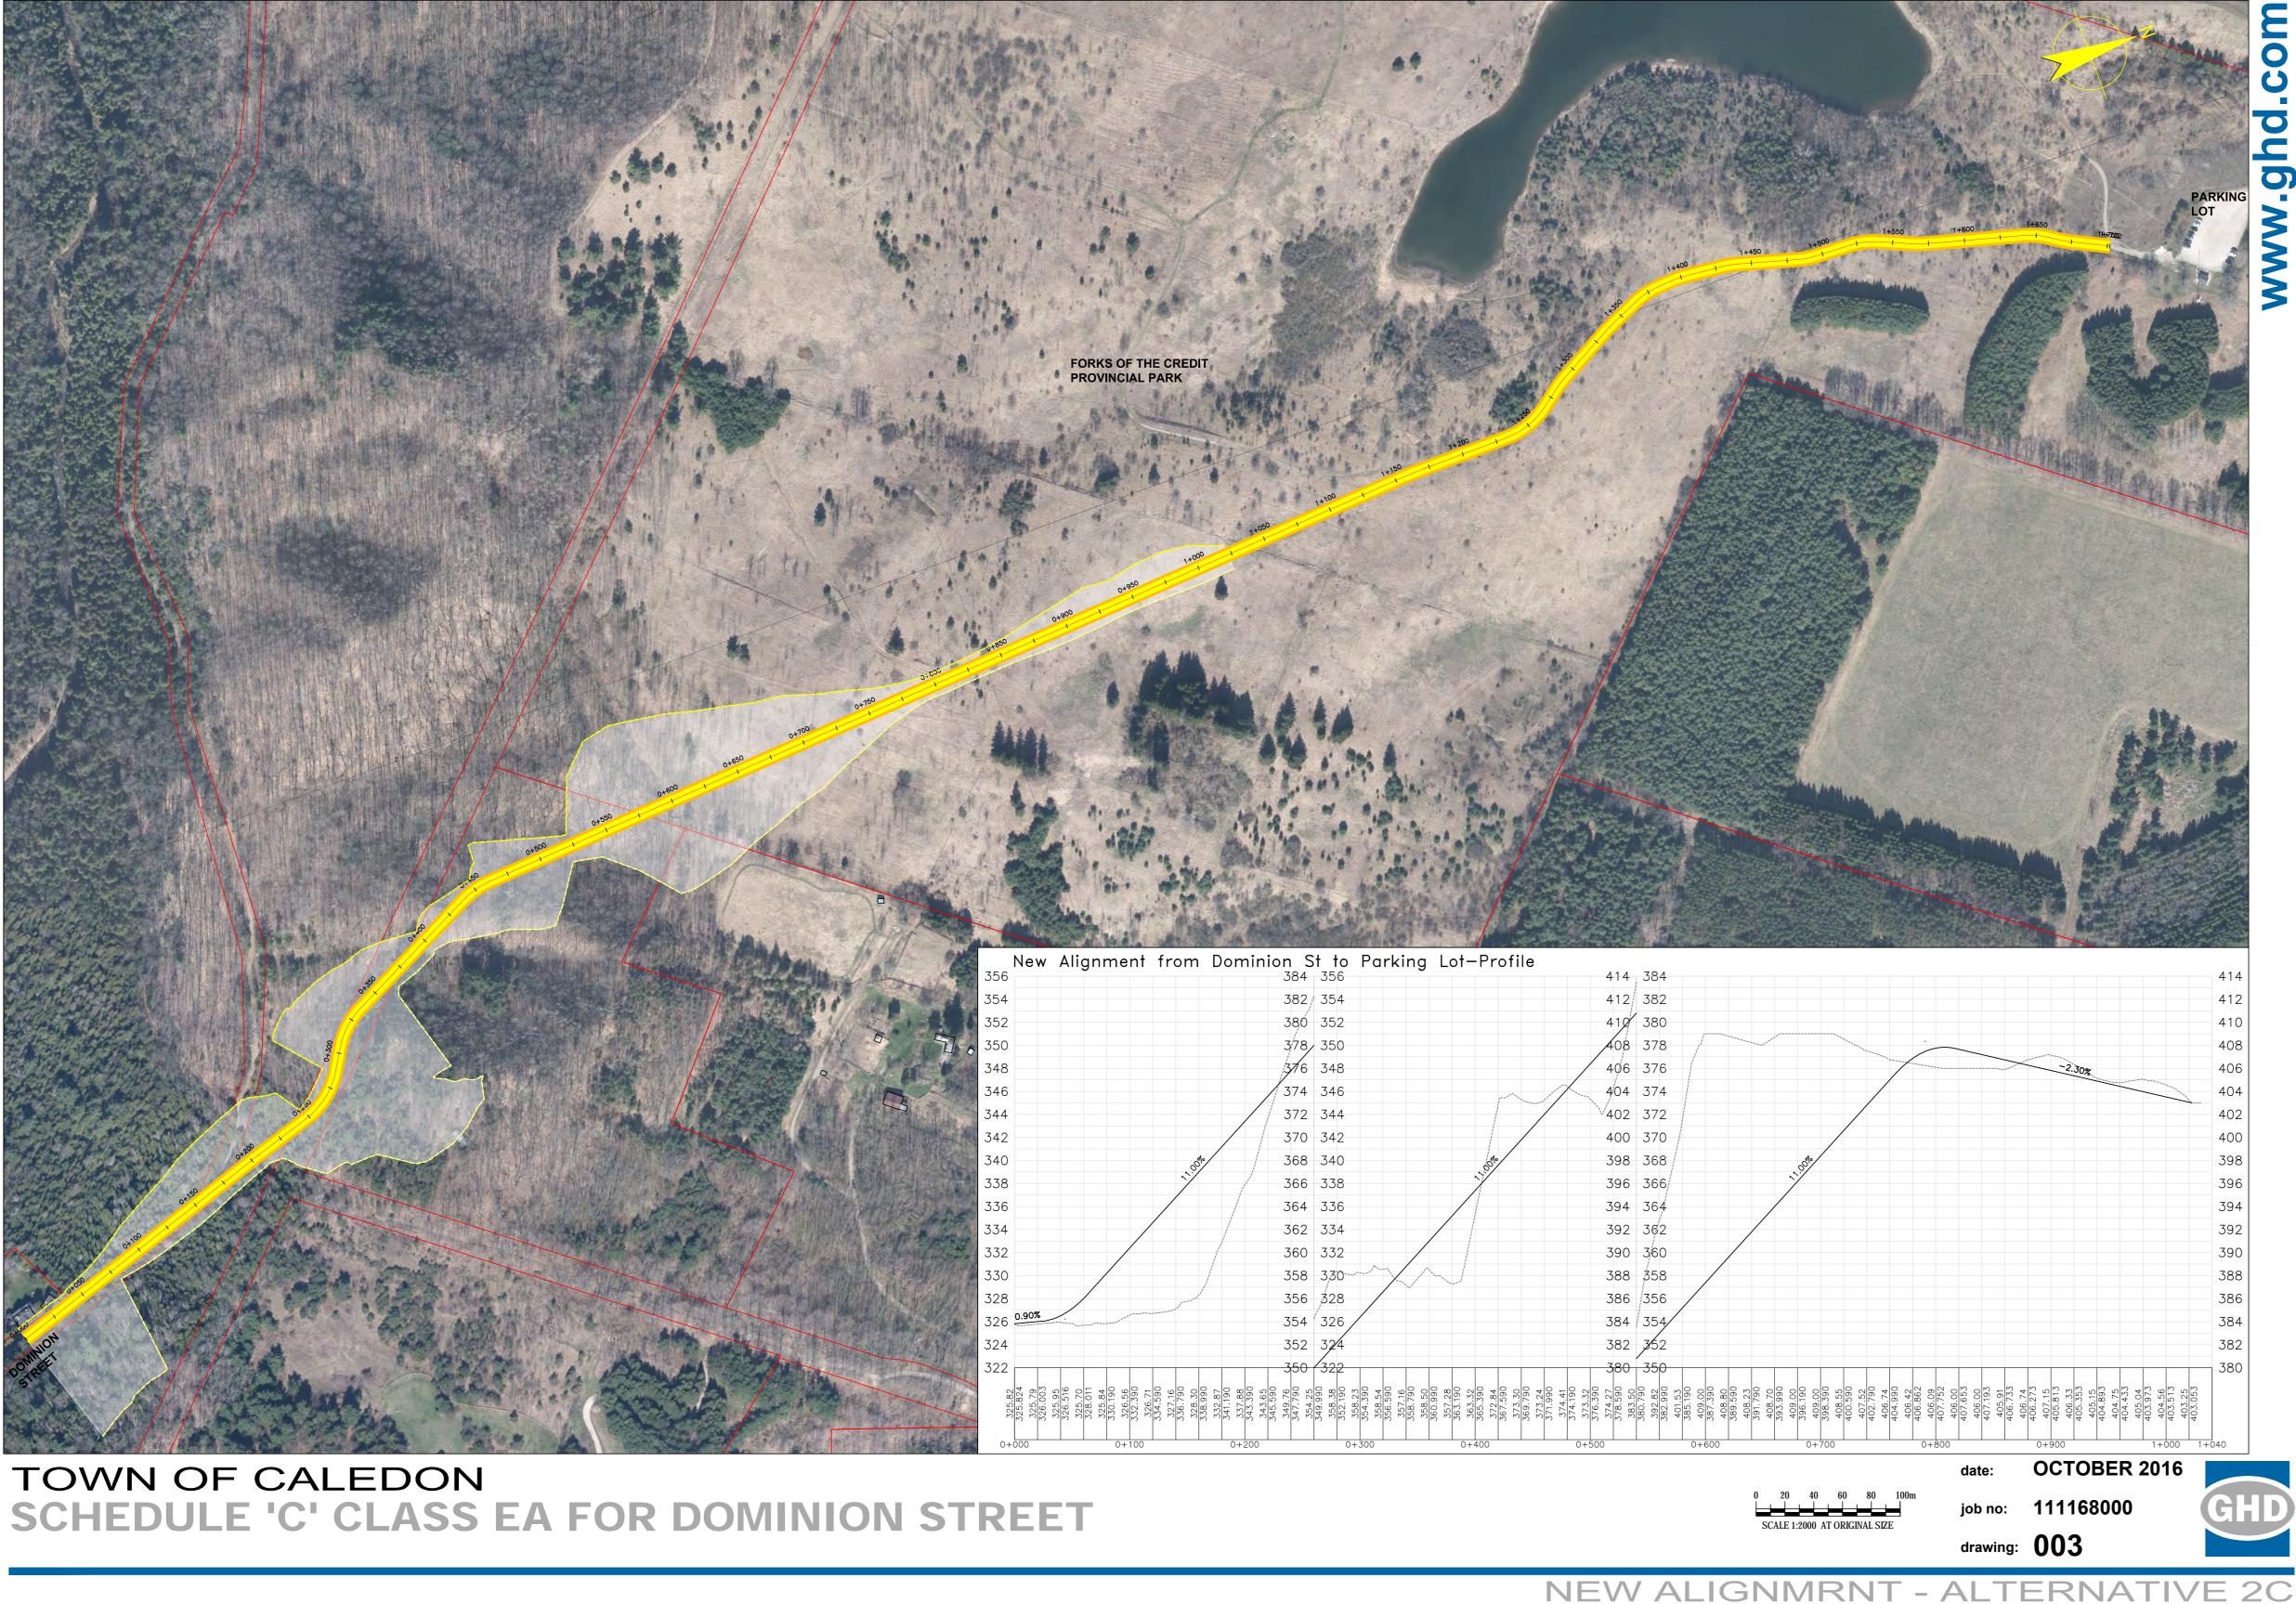
### **ALTERNATIVE 2C RE-ALIGNMENT via FORKS OF THE CREDIT PROVINCIAL PARK** PARKING LOT

Alternative 2C involves the northern extension of Dominion Street following the alignment of the existing Bruce Trail, connecting to the Forks of the Credit Provincial Park parking lot. The connection would require significant cuts in excess of 20m for grade of 11 percent, maximum for a low volume rural roadway.

The estimated surface area potentially impacted from the preliminary configuration of Alterntaive 2C is approx. **59,000 m**<sup>2</sup>

An approximate 1700 metres of additional road would be required to facilitate Alterntaive 2C.

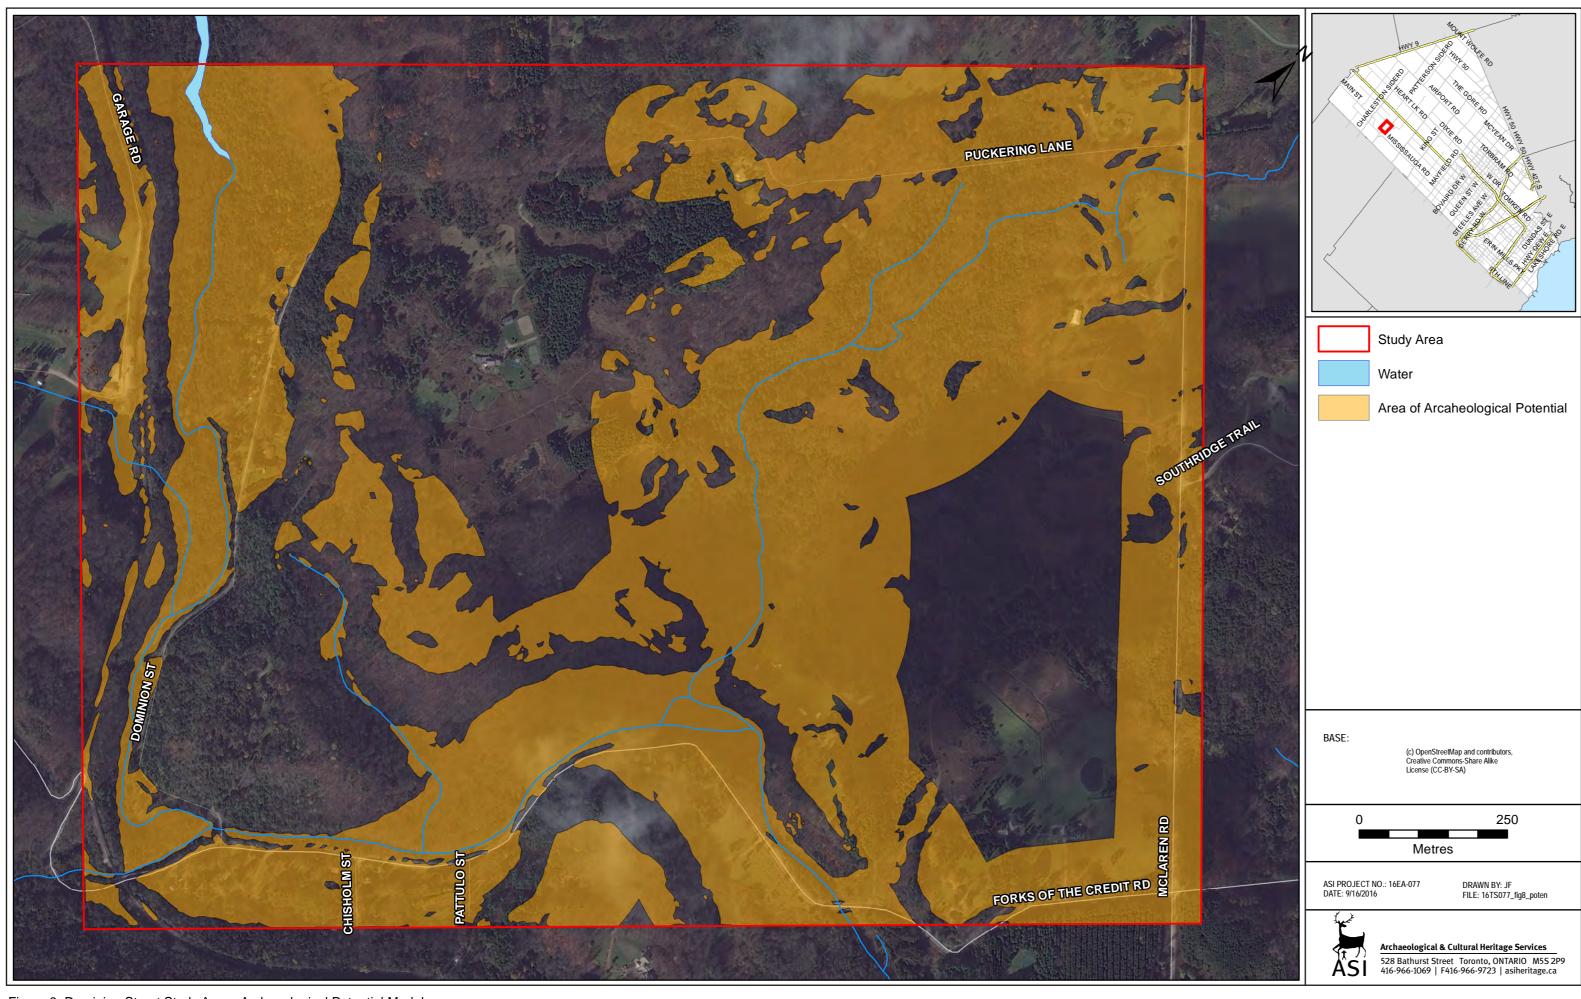
Figure 8: Dominion Street Study Area - Archaeological Potential Model

The study area meets the following criteria which are indicative of archaeological potential:

- Proximity to Euro-Canadian settlements (farmsteads; early industry; villages of Belfountain; Cataract; Brimstone); • Proximity to historic transportation routes (Credit Valley
- Railway; Dominion Street; Forks of the Credit
- Road, McLaren Road, Puckering Lane);
- Proximity to previously registered archaeological sites • Proximity to water sources (Credit River);
- Well-drained sandy soils (Caledon and Pontypool sandyloams); and,
- Distinct land formations (Oak Ridges Moraine; Niagara Escarpment).

Archaeological potential within the Study Area is also dependent on the degree of of disturbance and physical features of the Study Area.

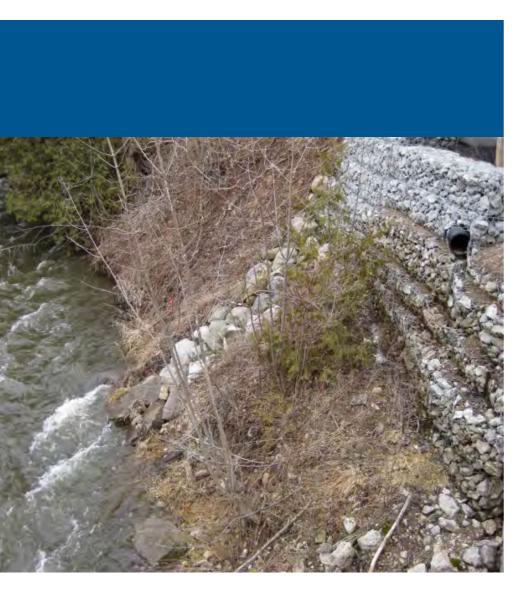
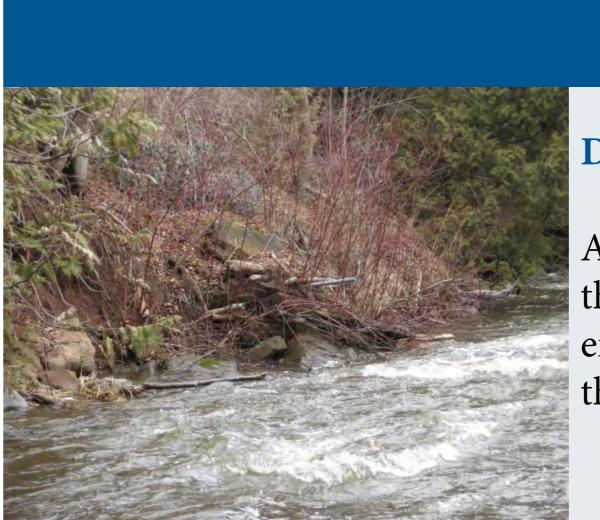
DESCRIPTION A previous slump is evident were gabion baskets have slid down the slope. The toe of slope appears to be stable due to the presence of dense shrubs. New erosion is evident just upstream of the slumped area at the left side of the photograph.

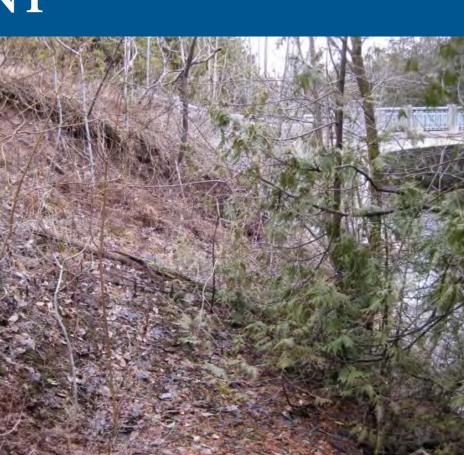
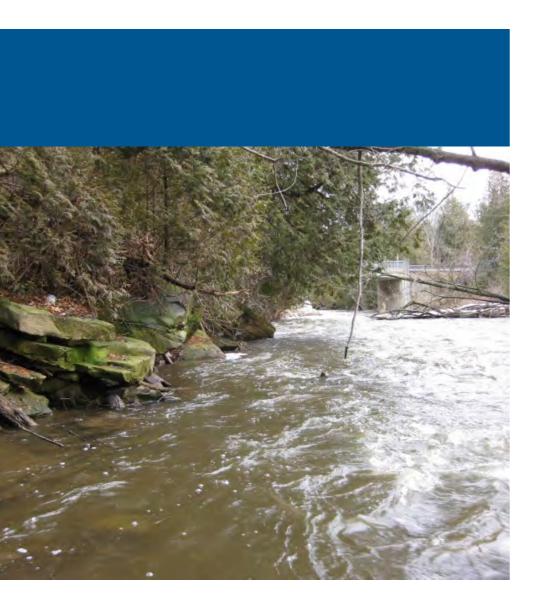
Erosion and slumping was observed at the toe of slope along the northwest quadrant at the Dominion Road bridge. Removal of fines from the toe of slope by the watercourse has resulted in slope instability which is threatening the abutments and roadway.

There was evidence of slumping immediately upstream of the bridge on Dominion Road. The slump likely occurred due to removal of toe of slope material by the watercourse. The toes of slope appeared relatively stable suggesting that material removed by the watercourse has been steadily replaced by slumping of the embankment.

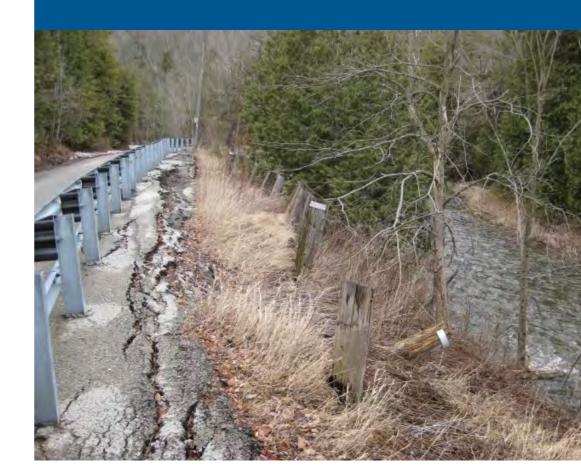
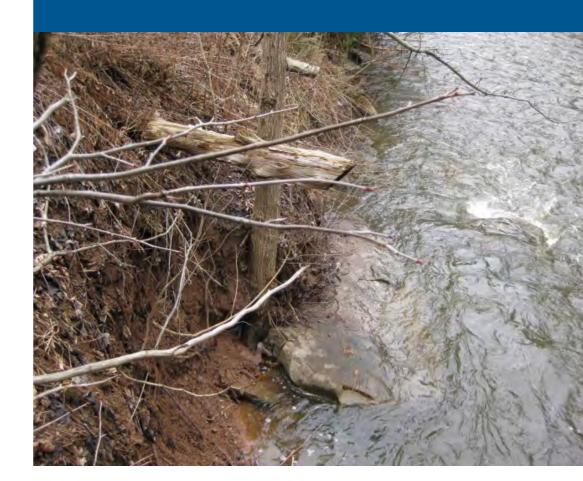
Evidence of toe erosion was observed at several locations where the road was close to the watercourse. The watercourse position appeared to be stable suggesting that the removal of fine bank material was replaced by the slumping banks which in turn resulted in the road slippage.

Road slippage where the watercourse runs close to the road. Any alternative where the road remains in place will require careful integration of geotechnical, geomorphic and aquatic habitat considerations.

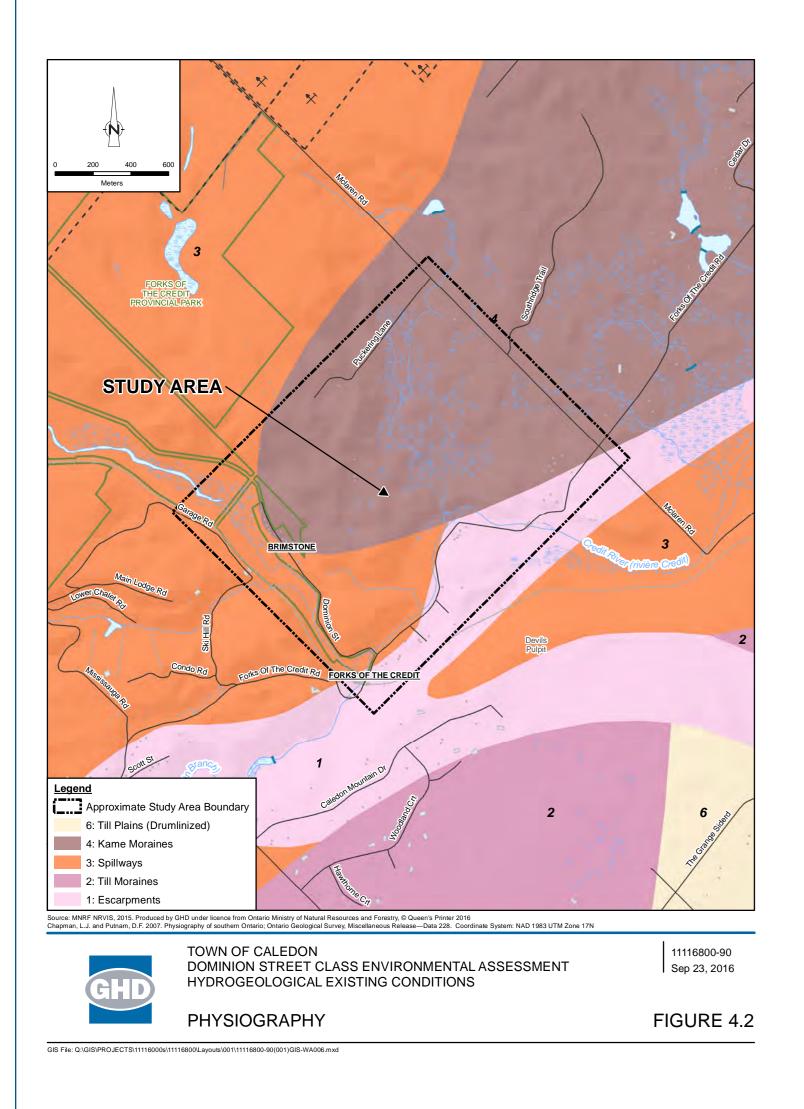
#### PHYSIOGRAPHY

The Credit River valley within the Study Area is primarily within the Niagara Escarpment physiographic region, which is characterized by a glacial spillway and the escarpment.

The Credit River is incised into the escarpment at an elevation of approximately 310 mAMSL (Above Mean Sea Level). The escarpment rises approximately 100 metres to an elevation of 410 mAMSL.

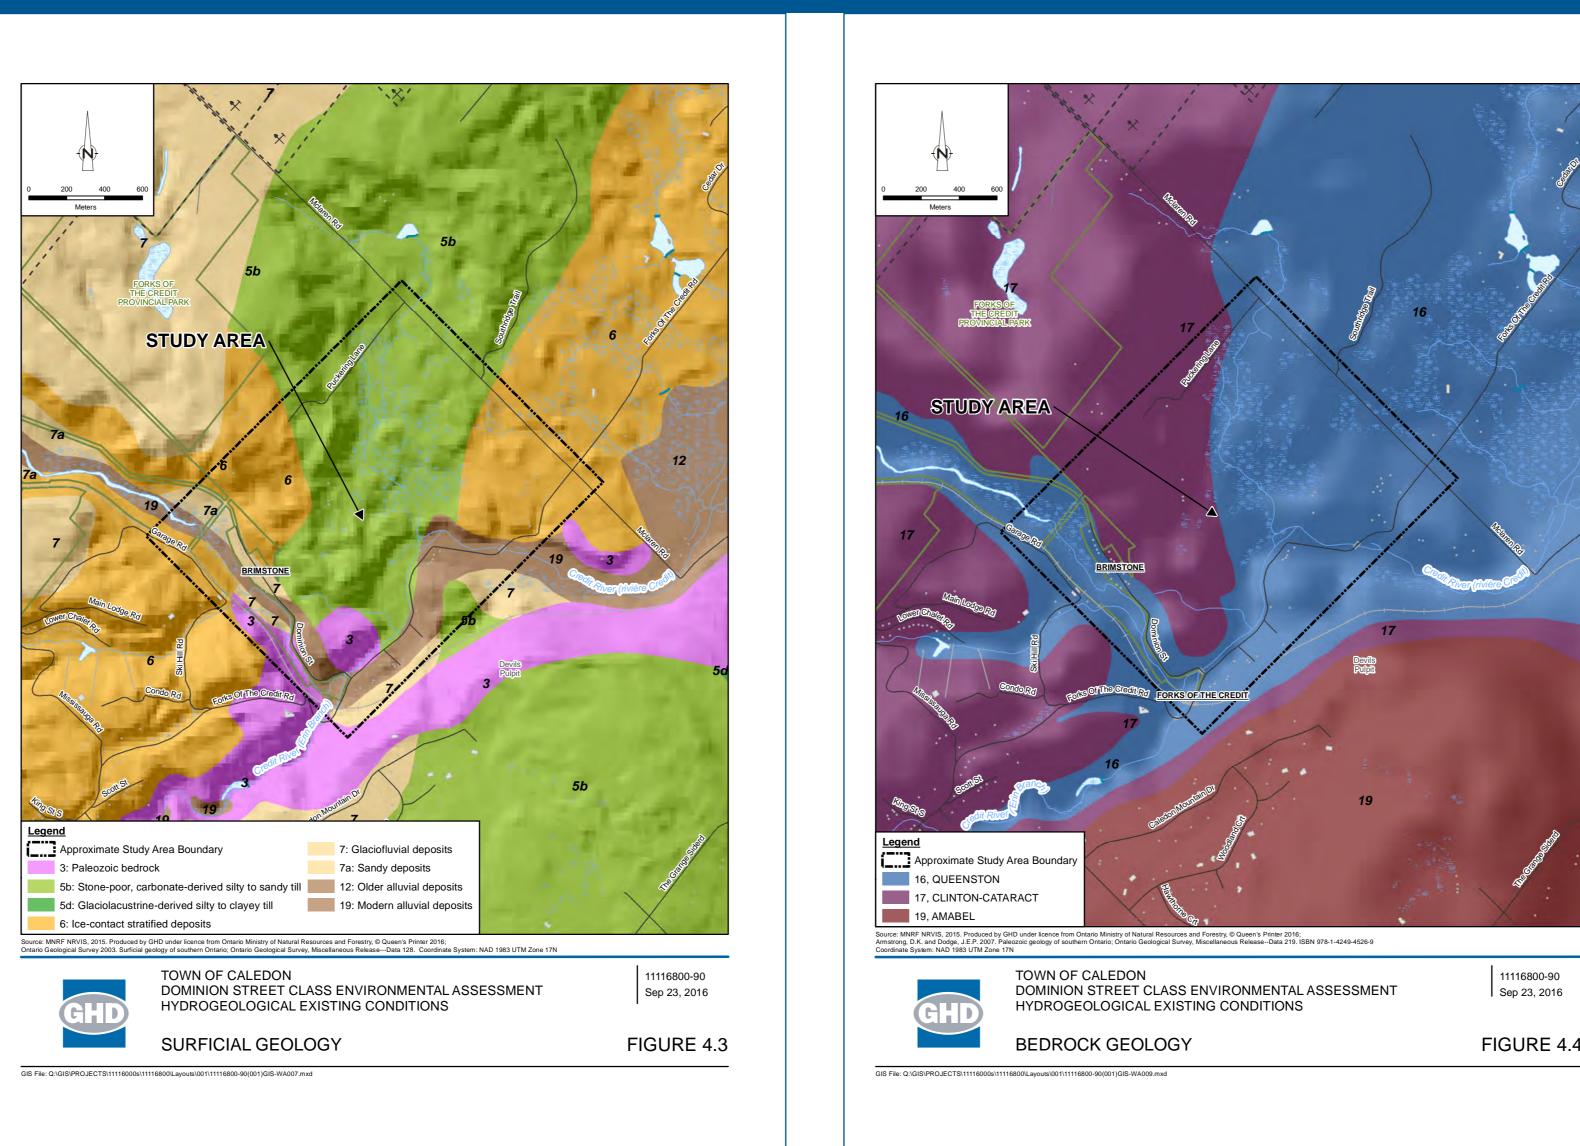
#### **SURFICIAL AND BEDROCK GEOLOGY**

Regional surficial geology mapping of the area indicates that the Credit River valley is underlain by glaciofluvial deposits, sandy deposit, modern alluvial deposits and bedrock.

Overburden underlying the Credit River Valley generally ranges from less than about 1 m in thickness to more than 30 metres thick and is described as a deposit of sand and gravel of varying thickness overlying shale bedrock. Outcrops of red shale of the Queenston Formation are found within the Credit River Valley at he Forks of the Credit.

• Modern alluvial deposits – clay, silt, sand gravel • Glaciofluvial deposits; sand, gravel • Queenston Formation (bedrock) – Shale.

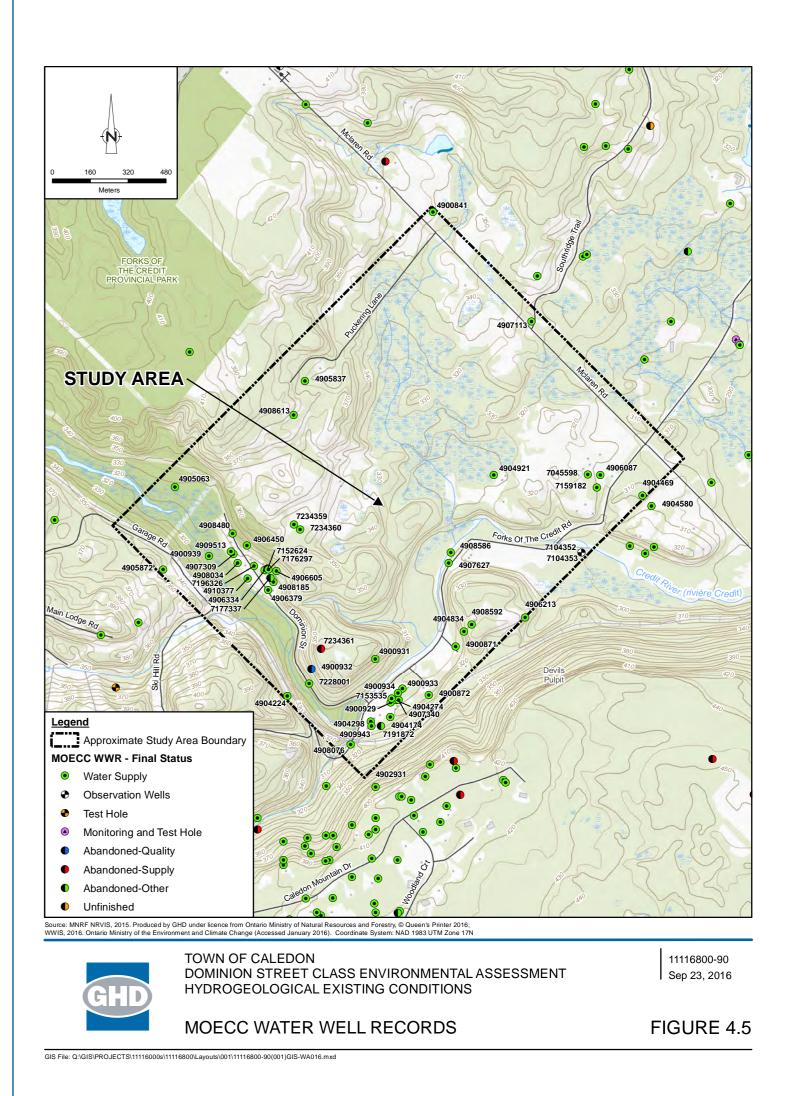
#### **MOECC WATER WELL RECORDS**

Review of the water well record information indicates that the majority of records in this area along Dominion Street and the Forks of the Credit Road near the bridge are for drilled wells (4 to 6-inch) which are completed in both the overburden and bedrock. Out of 30 selected well records 10 wells are completed in the overburden and 20 are completed in shale bedrock. All of the wells are used for domestic purposes.
